Diagnostic Flow Charts... Do They Always Work?

Technical article by:
Bruce Bonebrake, Managing Editor at BAT Auto

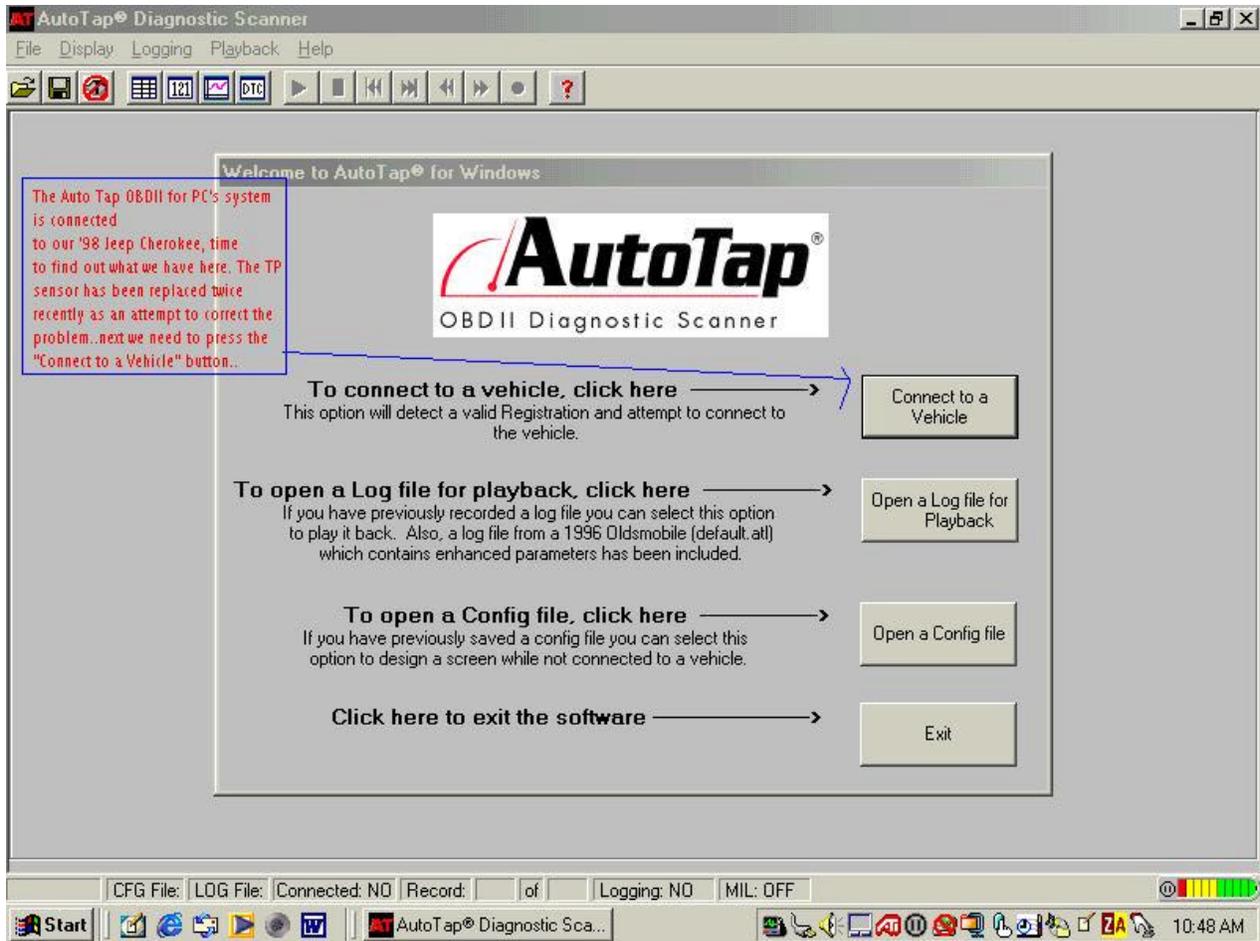
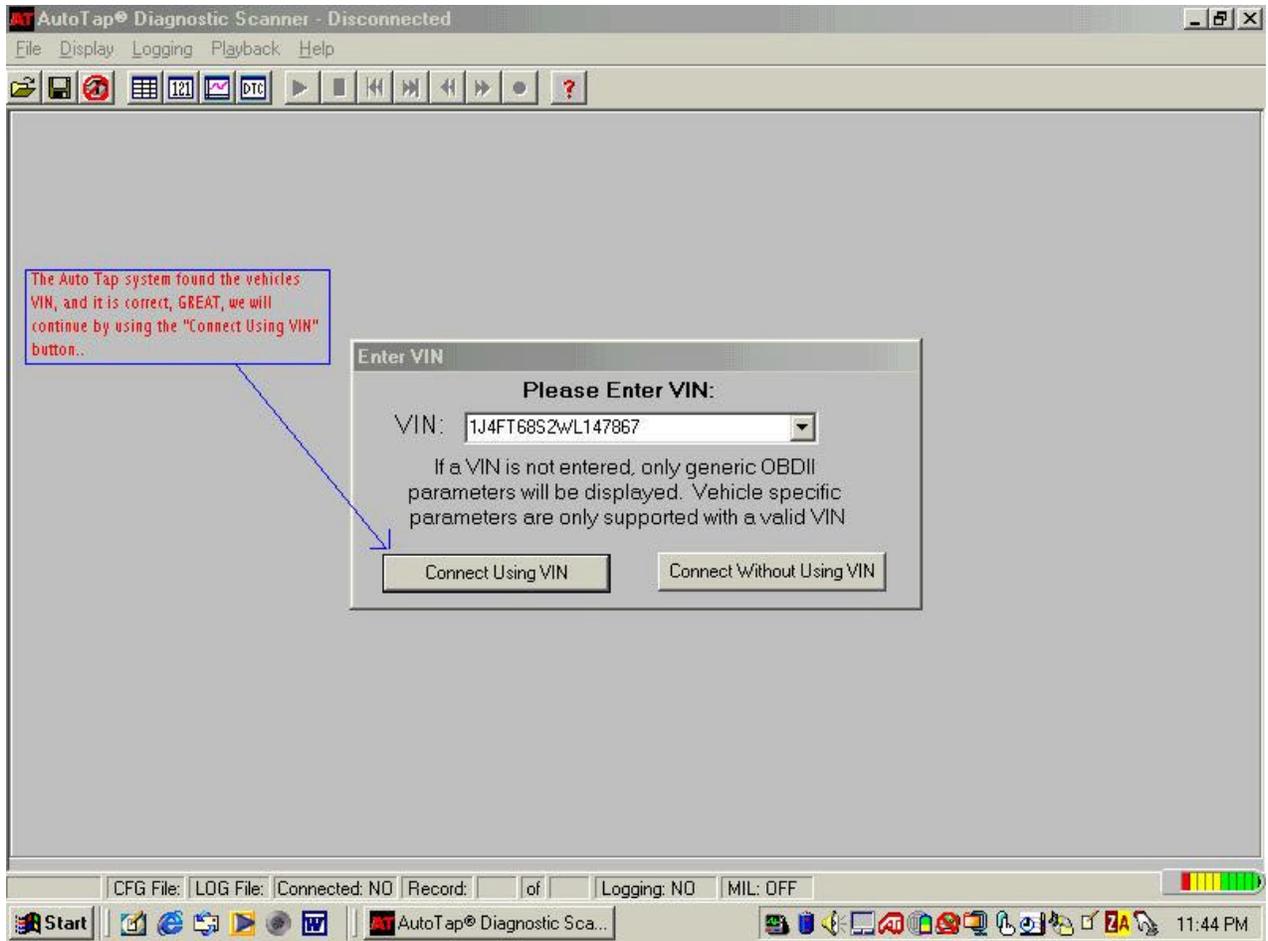
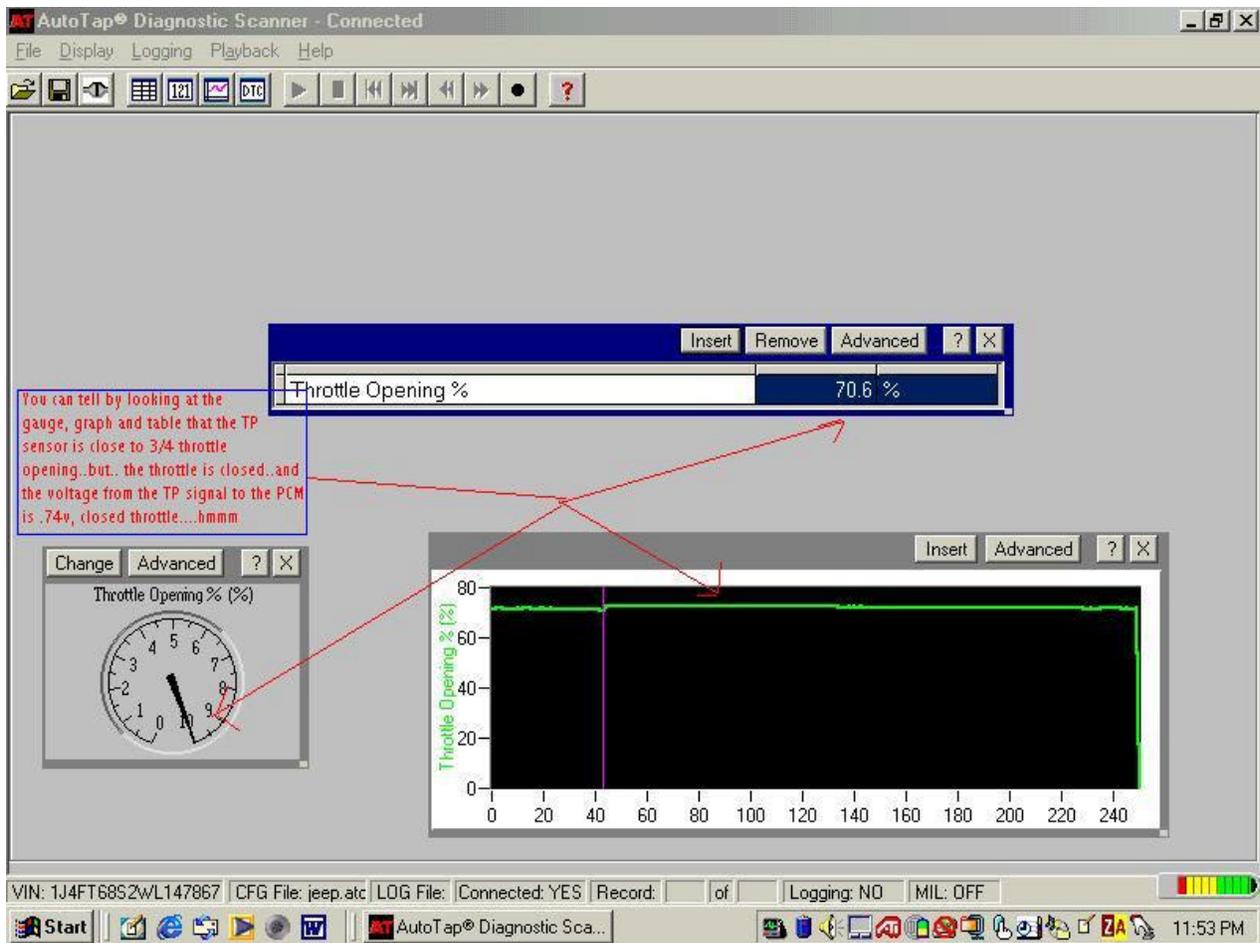
After reviewing the vehicle's wiring diagram, the PO700 was most likely set due to the PO123 DTC since the signal wire from the TP sensor goes to both the PCM and the TCM. By looking at the TP sensor output on the AutoTap system, it was obvious that I indeed had a problem with the TP circuit:

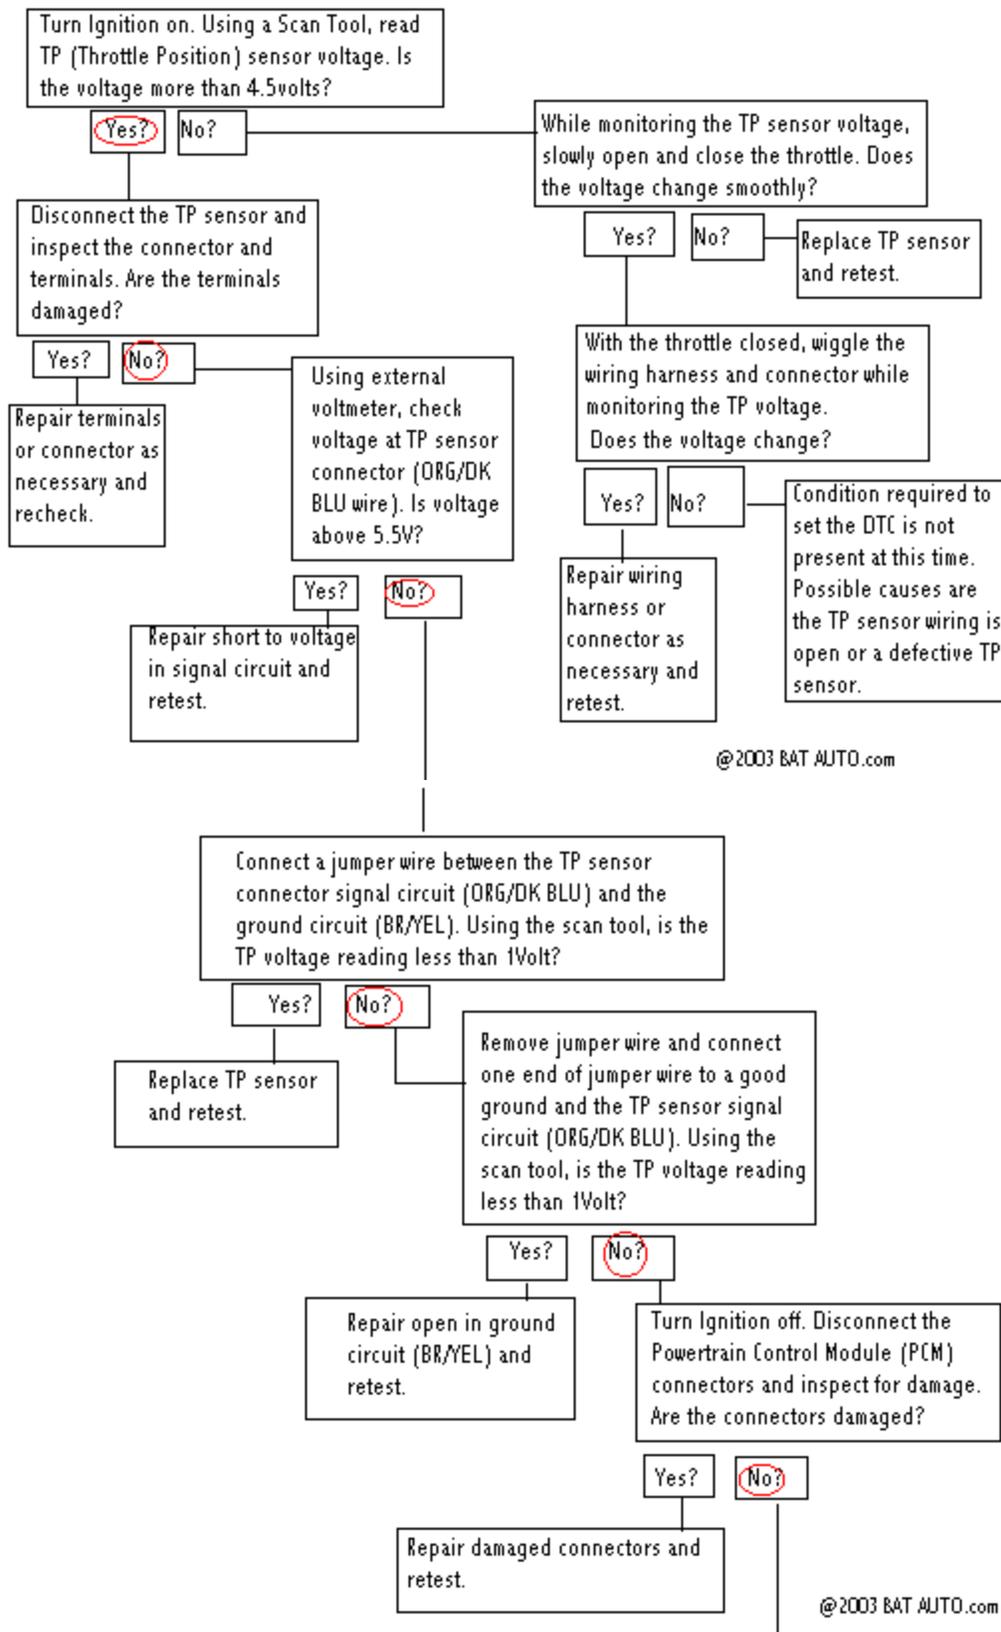
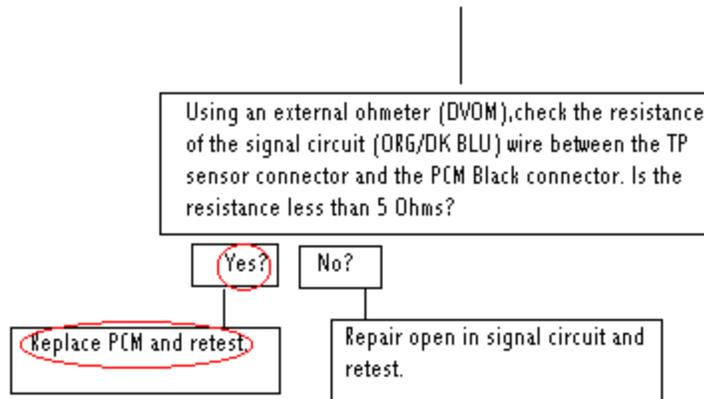
The repair manual had a flow chart listed for this DTC. Starting at the beginning, the system test begins: (Note: follow the red ovals. This is the direction of the Jeep's diagnosis)

Well, the flow chart diagnosis has been completed and the final result is a defective PCM. I just had a strange feeling and I just cannot seem to accept that. I work on a lot of these vehicles and I have never had to replace the PCM. As luck would have it, one of my own vehicles is the identical twin to this vehicle. Same year, make model, engine, everything right down to the color!! Since it was only a matter of four screws and three connectors and I decided to try my PCM on the problem vehicle. Just as my feeling had told me, the other PCM made no difference, the exact same problem. I even connected the computer from the problem vehicle to mine, no problems at all, the PCM worked perfectly. Well, luckily, I only lost about 20 minutes of my time, and at the chance that I could have saved the customer the expense of further diagnosis, it was time well spent. So what happened? What went wrong? The diagnostic trouble chart was carefully followed and yet the end result was incorrect? Was the flow chart misleading? Absolutely NOT, one thing to KEEP IN MIND when following the flow charts is that the "MOST LIKELY" cause will be shown. There is no way to know exactly what fails from one case to another. I don't fault the information at all, as a matter of fact, even though the problem was not yet known, I do know, by following the flow chart, what areas are correct.

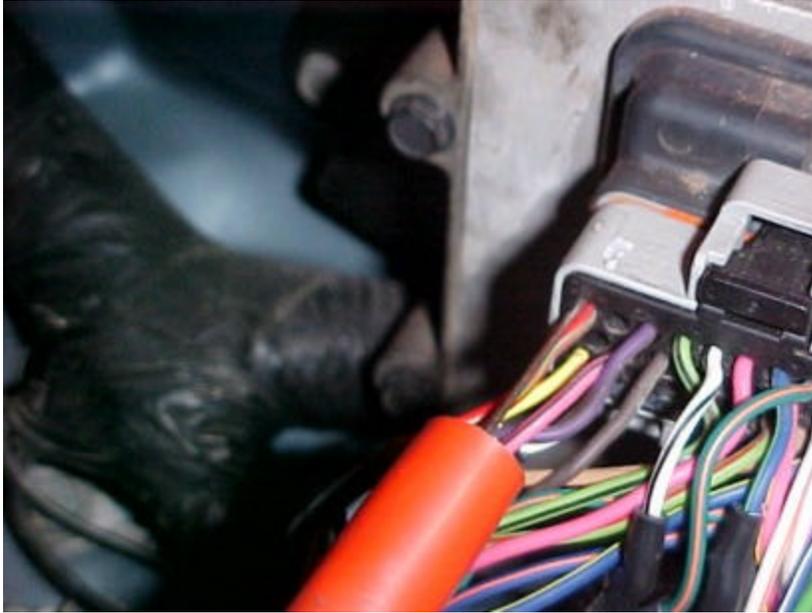
Well, I know what is reading correctly and I know now that I have an unusual problem on my hands. I decided to concentrate on all of the circuits at the PCM. There are three connectors and first I started with the TP signal wire (ORG/DK BLU) at the PCM connector and was curious what the voltage was from the TP sensor to the PCM is with everything connected and the Ignition on. The sensor voltage was .52Volts from the TP sensor to the PCM...normal. And while watching the voltage and operating the throttle, the voltage changed smoothly and gradually...again, normal. So the TP sensor was operating correctly but for some reason the PCM was changing the reading. One by one I checked the PCM circuits. First the Grounds and the Power circuits... all ok. Finally, on the last connector, I found something odd. The "Cruise Control Switch In" circuit to the PCM was reading 12Volts, and it should have been 0.00Volts. Then I found that the circuit was still reading 12Volts with the Ignition OFF. Hmmmm... Look at the pictures below of the circuit:

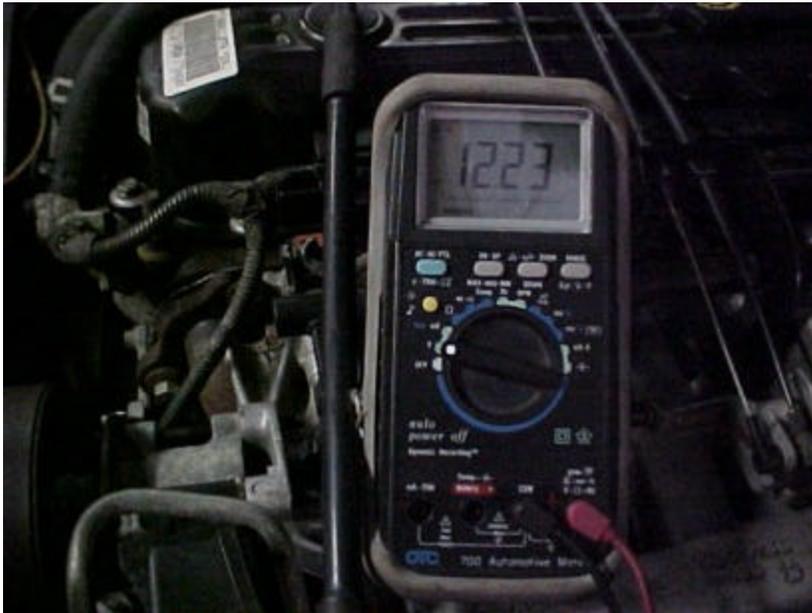
With the backprobe in place on the TAN/RED wire at the PCM connector (Cruise Control Switch IN), and the DVOM Positive lead connected to the backprobe. The DVOM Negative lead to a good ground, you can see that the circuit is reading 12.23Volts with the Ignition off! The reading should be 0.00Volts.

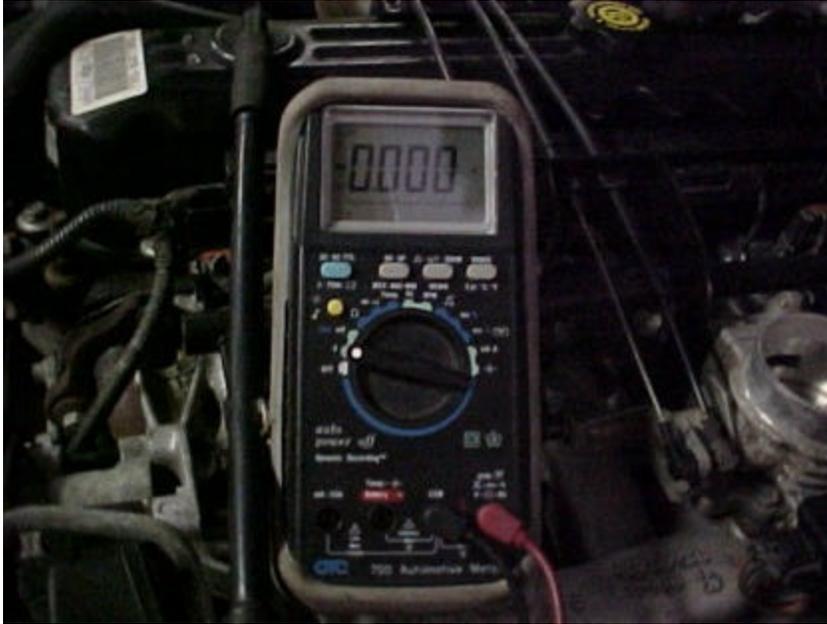
Well, I have stumbled on to a problem, but what was causing this? After researching the wiring diagram of the Cruise Control System, the problem had to be that somehow 12Volts, or battery voltage was shorted to the cruise On/Off switch in the steering wheel. This vehicle does have SRS (air bag) and the system performs the system test and the SRS light goes out (working normally) and the horn does work...wait a minute, the horn, that is a 12Volt battery circuit, well, the horn contact in the steering wheel supplies ground to the horn relay to honk the horn, but, if the horn switch isn't grounded (commanding the horn to honk) then the 12Volts supplied to the relay coil of the horn relay would be present until the horn switch supplied ground to the circuit. One way to find out if I am on the right path:

The DVOM reading at the left, 0.00Volts was taken at the Cruise Control Switch In to the PCM while the horn was honking.

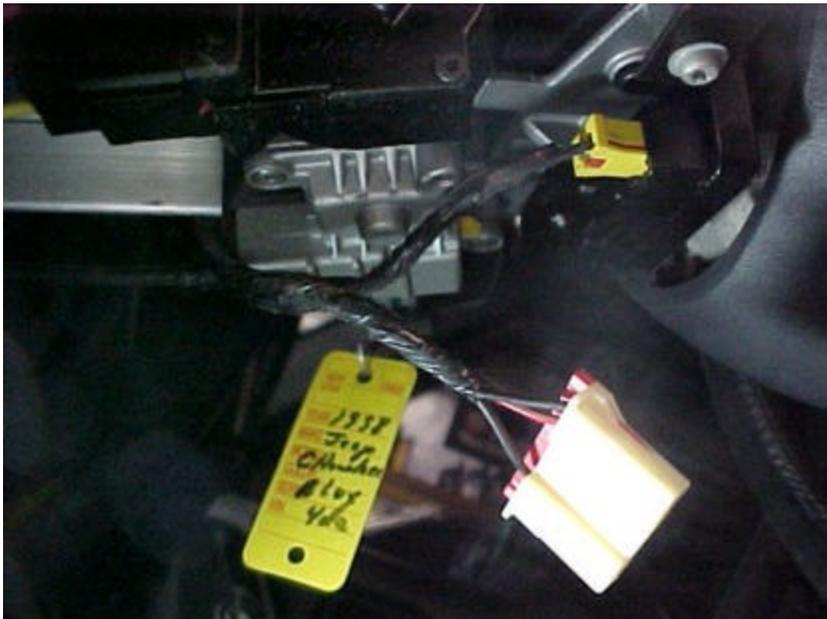
It looks like I have found the problem area. The question is, would this be the cause of my TP problem that I am trying to correct? Well, there is one sure way to find out:

By removing the steering column top and bottom plastic halves (covers), the clockspring connectors are easy to disconnect.
CAUTION!!!! (NOTE: the SRS Yellow connector is STILL connected. DO NOT disconnect this connector without first consulting your repair information!!!!)

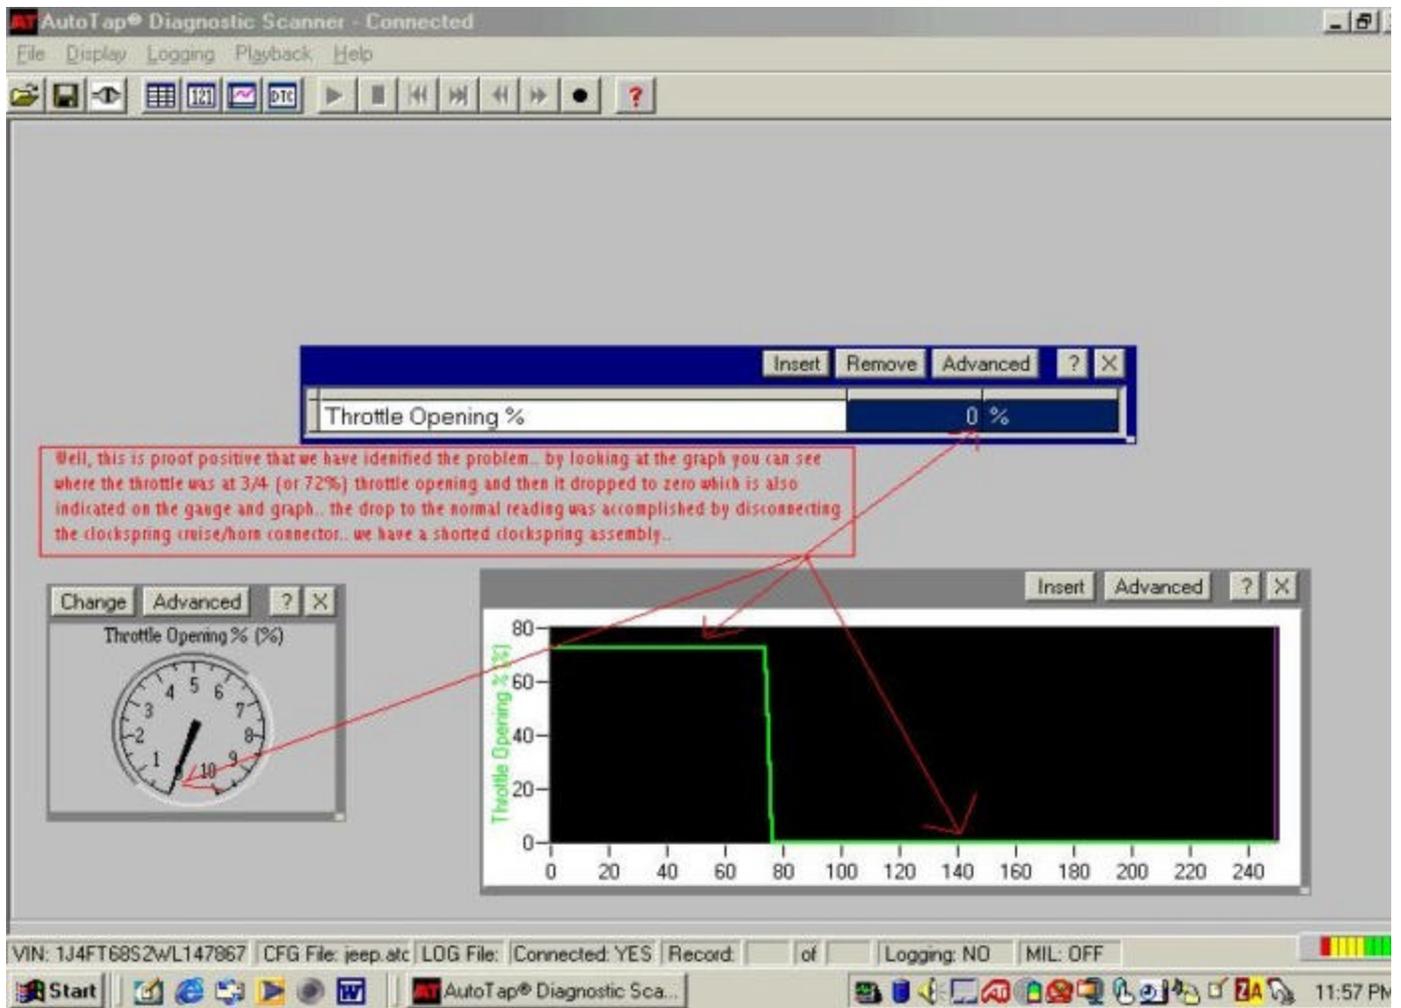
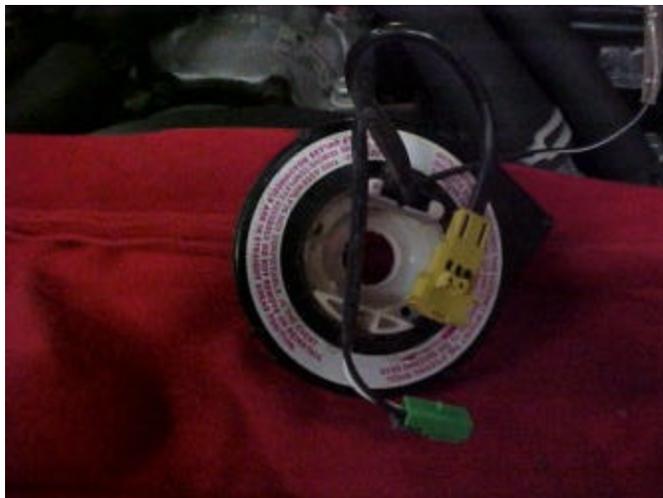
Well, here is our problem, a defective clockspring assembly. I replaced the clockspring, rechecked the TP circuit and it is now working perfectly!! I cleared the DTC's and test drove the vehicle. It runs perfectly, no Check Engine light and the cruise works great!!
